**MITIGATING BIOFILM GROWTH THROUGH THE
MODIFICATION OF CONCRETE DESIGN AND PRACTICE**

A Thesis
Presented to
The Academic Faculty

Georgia Institute of Technology

May 2008

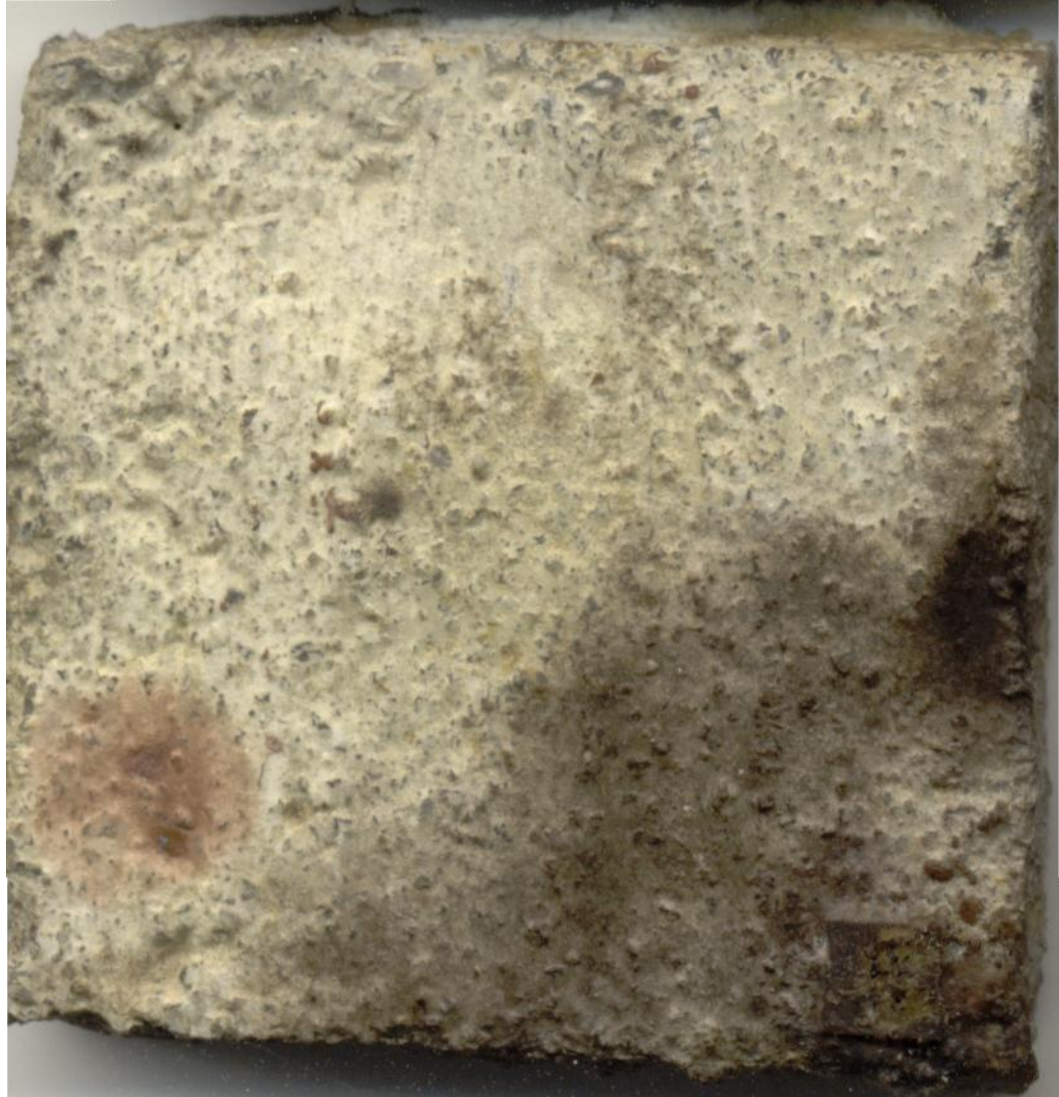
Figure 5.27 - Tile without acrylic coating ($w/cm = 0.5$), inoculated with *Atlanta* microbes
